**Agenda**  
**City of Monona Landmarks Commission**  
**Monona Public Library – Municipal Room**  
**1000 Nichols Road, Monona, WI**  
**Wednesday November 16, 2016**  
**4:30 p.m.**

**A. Review of Draft Report from Architectural Historian Charles Quagliana Regarding Restoration Options for the Springhaven Pagoda.**

This document is to serve as a decision making guide for the City of Monona Landmarks Commission, and other City of Monona elected and appointed decision makers to evaluate future preservation options for the Springhaven Pagoda, a City of Monona Landmark.

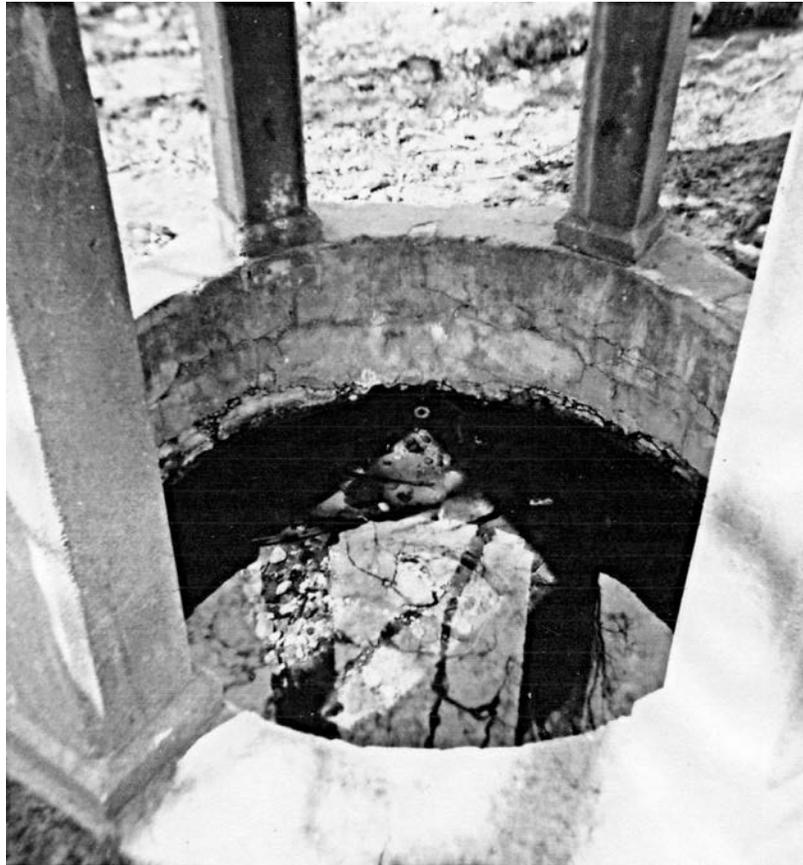
**Figure 3: Pagoda's basin c. 1951**

has stood sentinel-like over a historic and storied spring that long ago stopped flowing.” The article continued, “On a gloomy Monday afternoon, the normally dry basin beneath the somewhat battered concrete pagoda...was filled with clear and flowing water. The water bubbled up and trickled down to a small pool, and then into Lake Monona.”<sup>6</sup> Such springs were once common around the shores of the Madison lakes. A state hydrogeologist noted their disappearance as more water is pumped to serve the area’s growing population which lowers the groundwater level that feeds the springs. He said, “They’re a good measure of the status of the natural hydrogeologic groundwater levels. When they go away, you know we’ve changed the system.”<sup>7</sup>

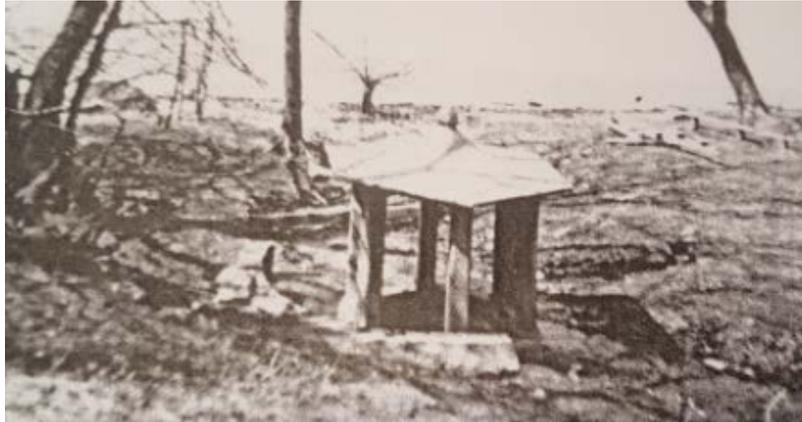
**Figure 5: View of the pagoda looking towards the lake, circa 1951**

The above photos are some of only a few known older images showing the pagoda with the finial in place on its roof-top. The stone wall to the south of the pagoda is visible in the photo, and the pagoda's foundation is exposed, especially on the north side. The image on the following page from 1975 shows the finial is still in place at that time but had been vandalized.

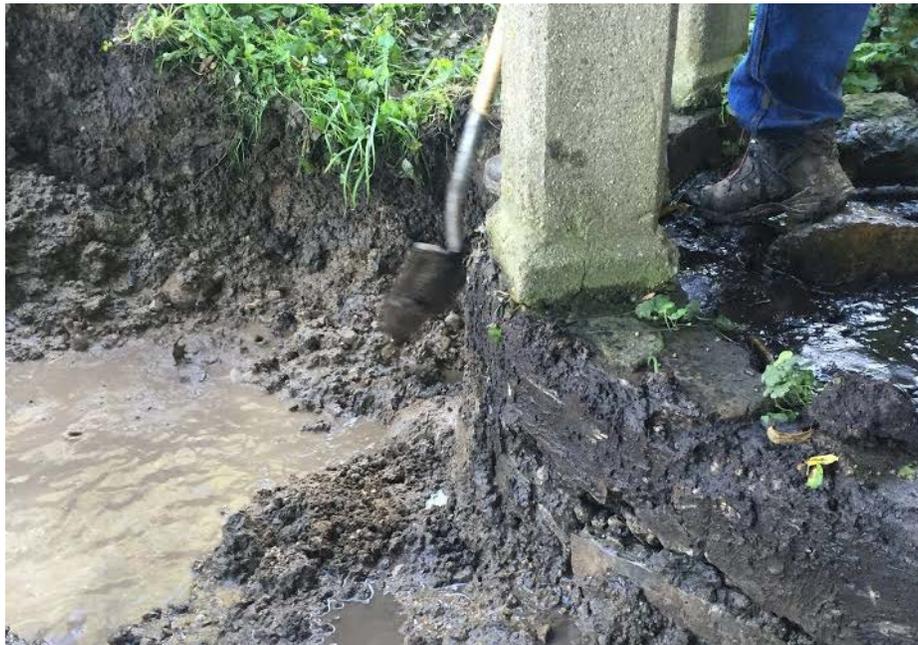
**Figure 9: Image of excavation on September 19, 2016 exposing the pagoda's foundation**

Given the shallow depth of the foundations not extending below frost level, more movement and displacement of the foundation was expected than was actually present. It is theorized that the constant temperature of the spring water in the spring basin helps prevent the ground around the pagoda from freezing, thereby minimizing the potential for any heaving and displacement. The foundations are in good condition and are performing adequately. The stone walls should be tuck pointed with a Type O mortar.

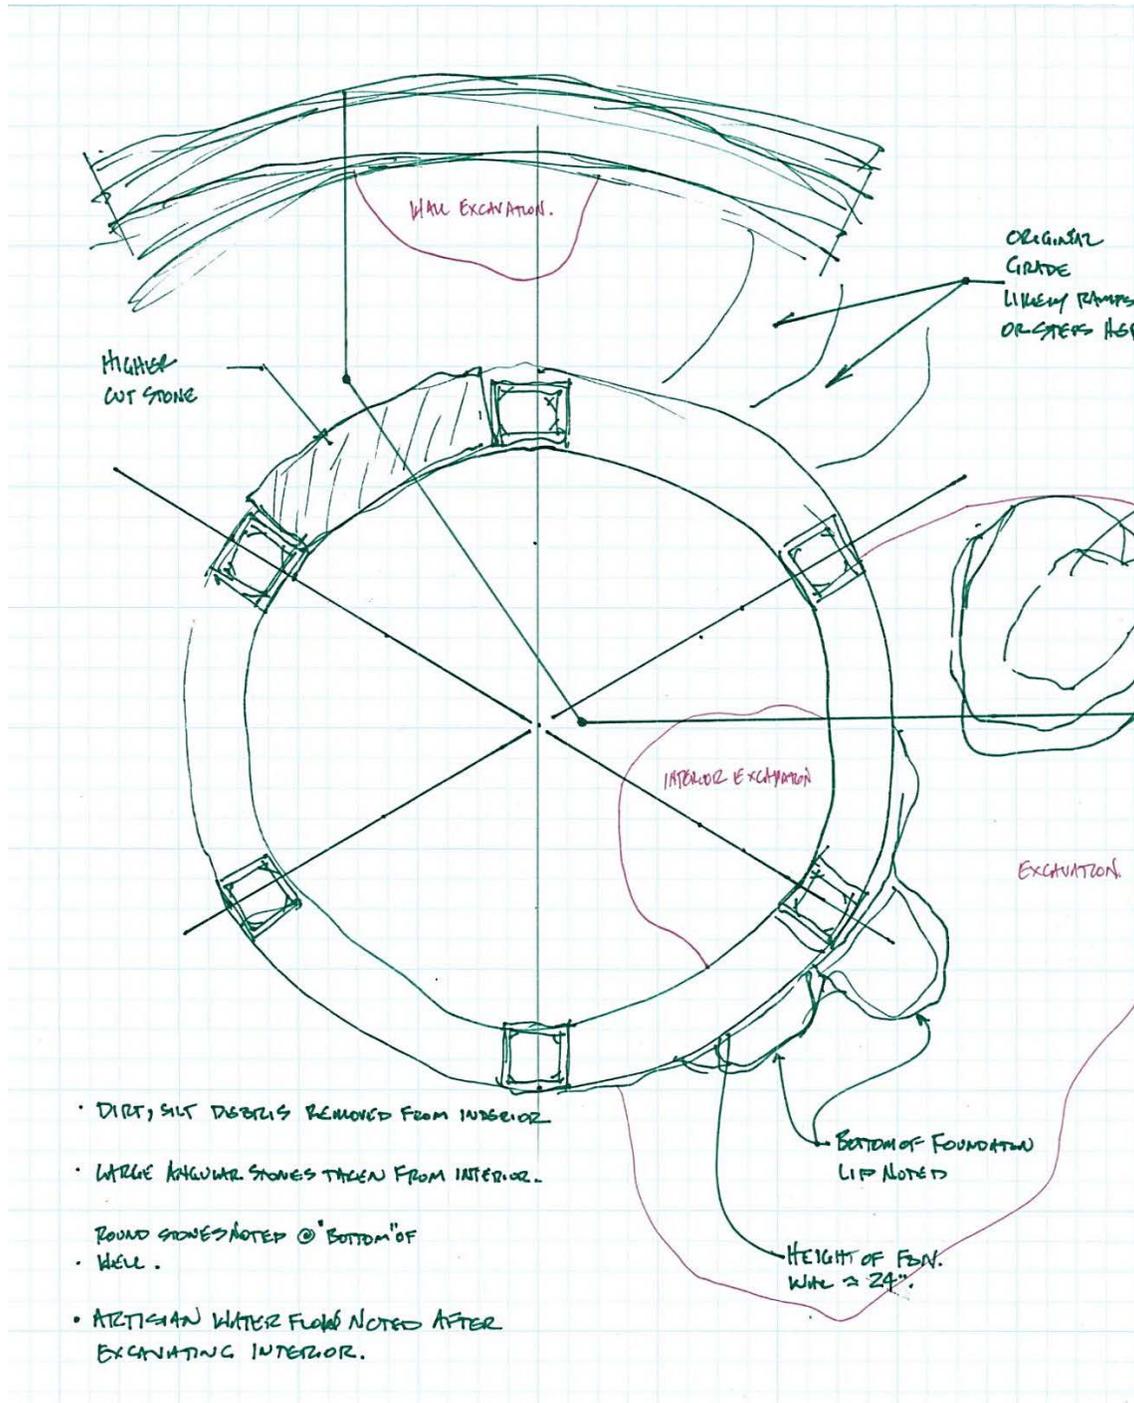
Figure 10: Sketch of pagoda / plan view. September 19, 2016

The stucco or parging covering the upper areas of the foundation wall and the interior of the spring basin is in poor condition. This coating provides a smooth and clean surface for the interior of the spring basin and a smooth surface for the top and sides of the foundation wall exposed to view. This surface is missing in many areas, loose in other locations and is at the end of its useful life. This parging will need to be completely replaced.

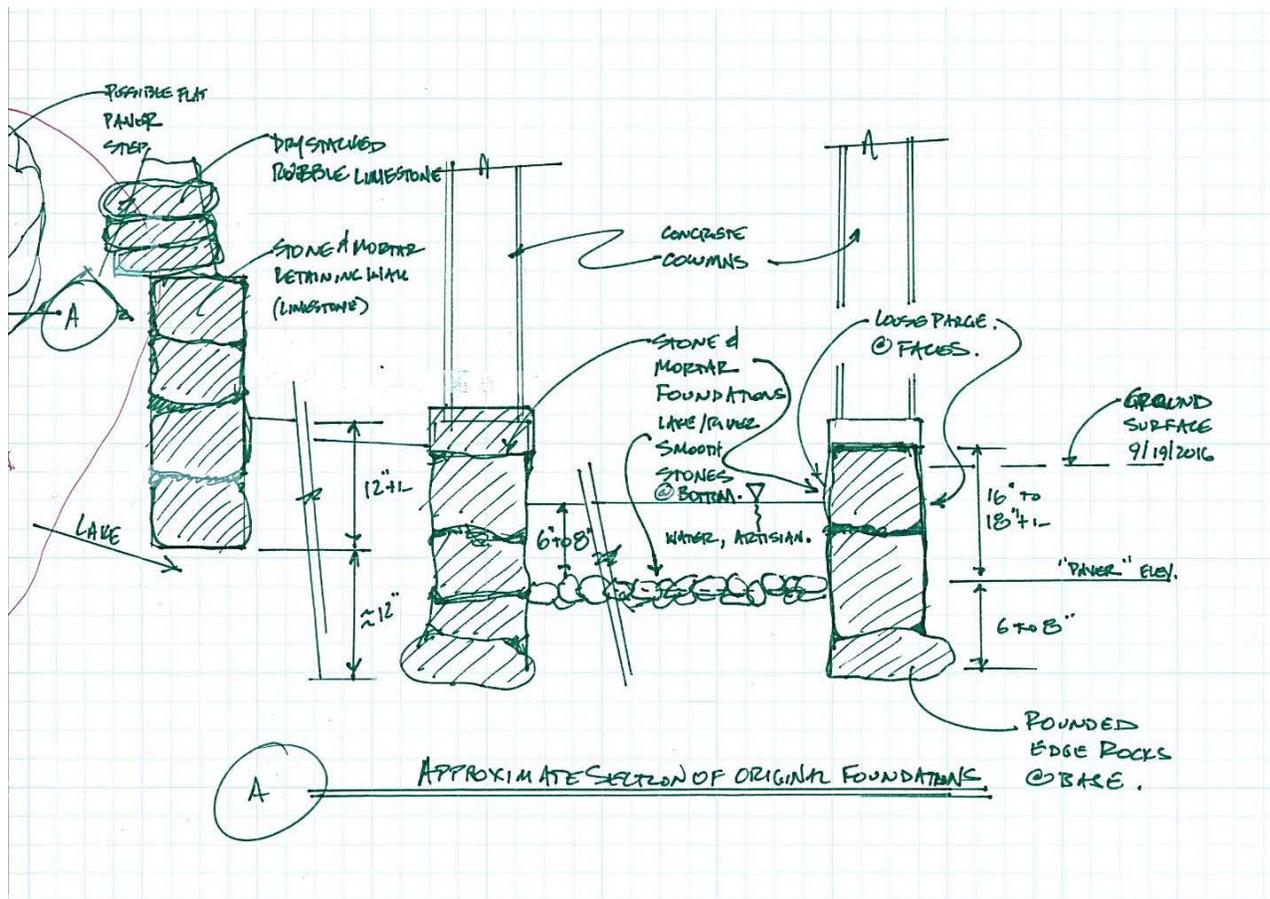
The basin is partially filled with debris and loose larger rocks. The bottom of the spring basin is lined with smooth stones placed about 8 inches below the water surface. See sketch below. The debris and large rocks will need to be removed, and the smooth stones removed to a depth of approximately 12 inches below the water level. This will facilitate the replacement of the parging. When parging is replaced, the smooth stones should then be replaced any missing stone replaced to provide a complete 6 inch layer of smooth stones.

**Figure 11: Section sketch of pagoda foundation. September 19, 2016**

Given the approximate date of construction of the pagoda sometime in the 1890's, the concrete is likely composed of locally sourced materials, including slaked lime, lake sand and coarse aggregate. There is likely no Portland cement content. The amount of reinforcing is not known but evidence of the use of lengths of barbed wire and various bolts is observed in the deteriorated edges of the roof structure. It is assumed that the columns have no reinforcing but are pinned to the foundation and beam above in some manner.

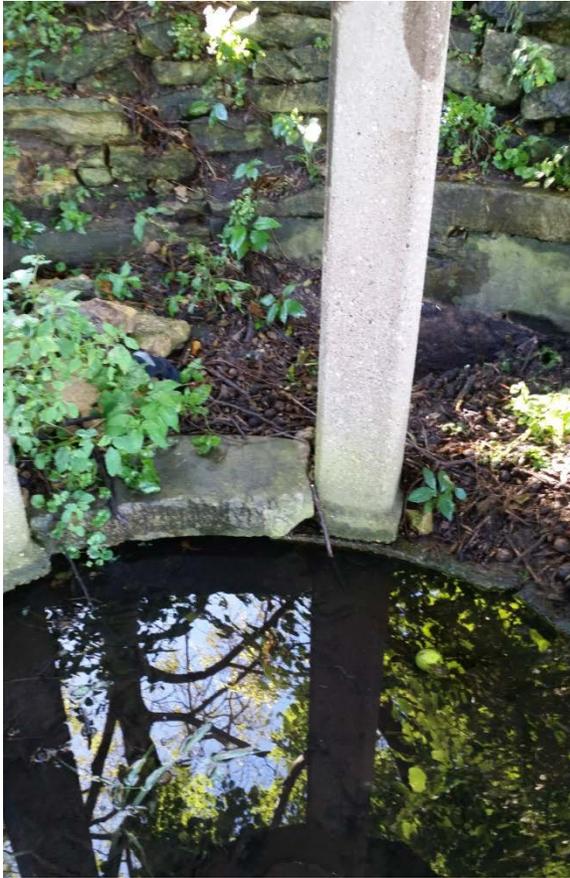
**Figure 12: Image of spring basin within pagoda.  
Note proximity of stone wall beyond.**

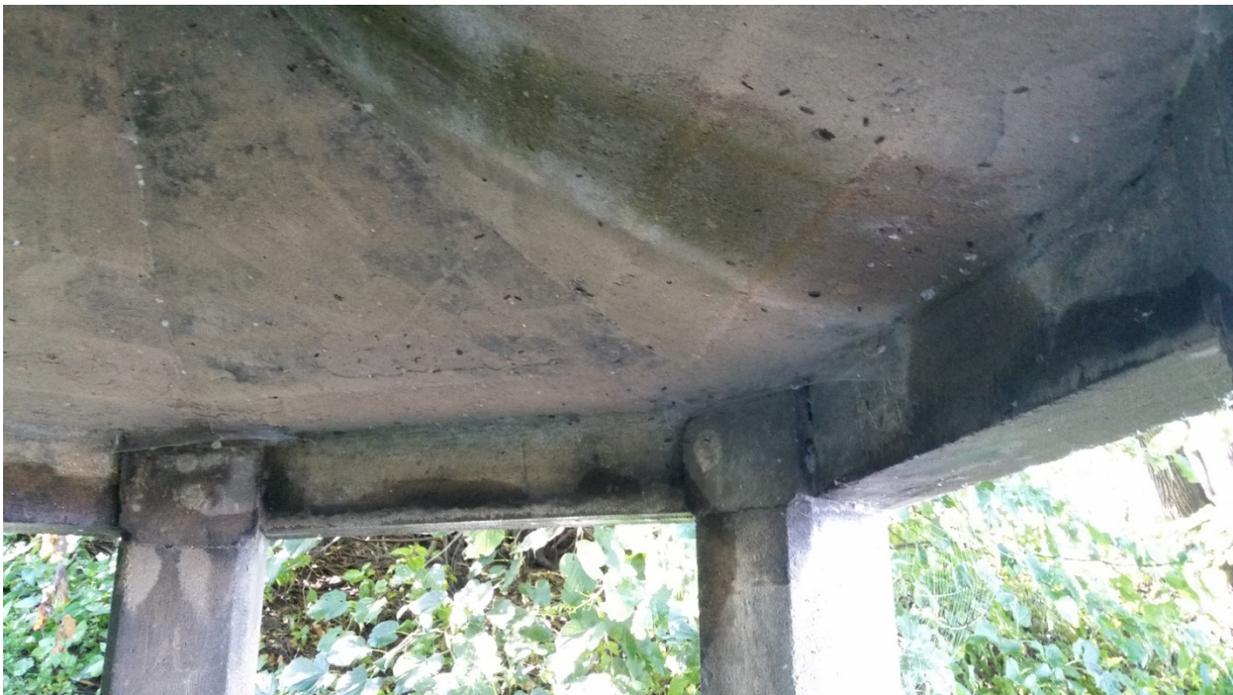
The concrete columns and beams are in good condition. The elements are structurally sound, straight and plumb and are performing the intended purpose. The concrete in the 8 inch square columns, with chamfered corners, have few cosmetic imperfections. There is some erosion of the surface on the exposed sides but these columns need no repair. The 6-inch-deep concrete ring beam atop the columns also needs no repair. It appears that the horizontal beam and the upright columns were poured separately. The beams and columns retain a high degree of utility and life expectancy. Although discussed, an application of a Siloxane coating to the concrete surfaces, to resist moisture penetration, is not needed or recommended at this time.

**Figure 13: Image of concrete column, beam and roof juncture. September 20, 2016**

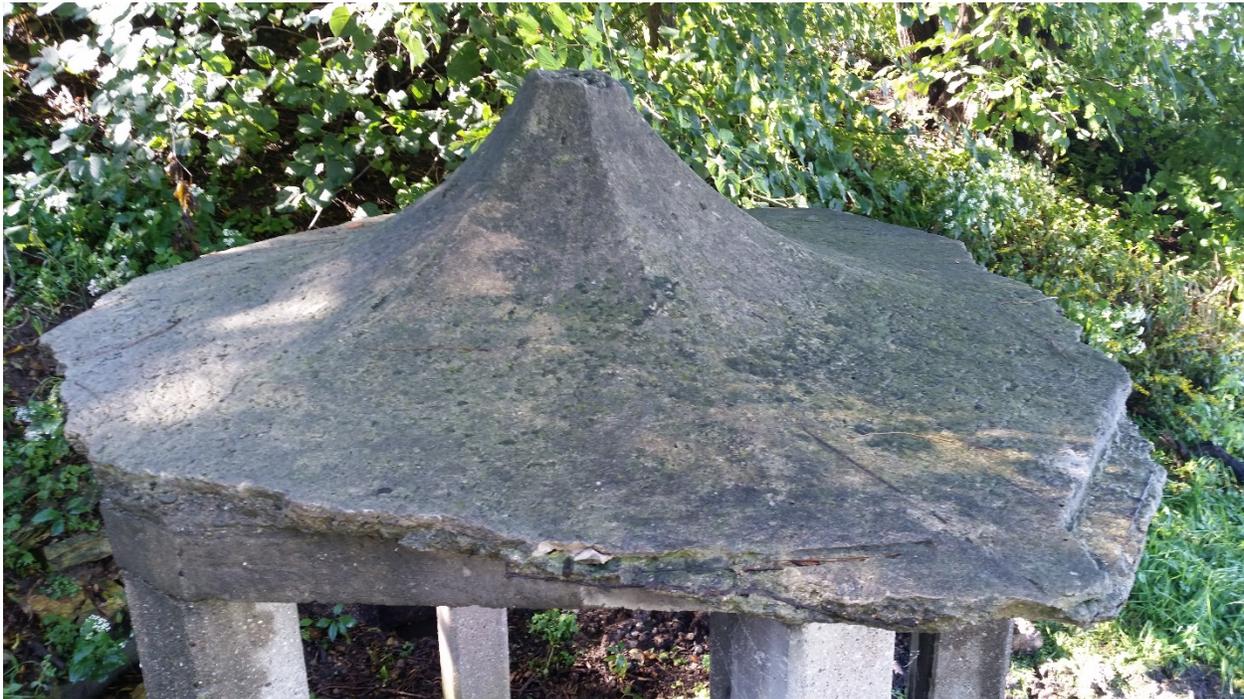
The roof of the pagoda is in overall poor condition. More than 90% of the cantilevered overhang is missing or significantly deteriorated or damaged. This cantilevered portion is less than 3 inches in thickness but over 12 inches wide, therefore very vulnerable to breakage at the edges.

The central portion of the roof, directly over the spring, is in fair condition. Although it is structurally sound and performing its intended purpose, there is some deterioration and pitting of the upper surface. The level of porosity of the roof concrete is high and water easily penetrates the surface causing the imbedded steel (barbed wire and bolts) to rust. As these elements rust they expand resulting in cracks and spalling of the concrete edges and surfaces. Also note that the original crown finial is missing.

Another source of roof damage is by vandalism. It is apparent that vandals can easily gain access to the roof from the hill to the east and south. Vandals standing and jumping on the roof have likely contributed to the roof edge damage and failure of the concrete cantilever.

**Figure 14: Image of concrete roof. September 20, 2016**

- Bracing and protection would be followed by removal of the roof from the concrete beams by carefully saw cutting at the juncture of the beam and roof. Again, the means and methods would be the responsibility of the contractor. Minor repairs to the beams may be needed because of the cutting process.

- The new precast roof would be shipped to the site and installed by crane. The new roof would be pinned to the existing concrete beams with stainless steel pins and epoxy.

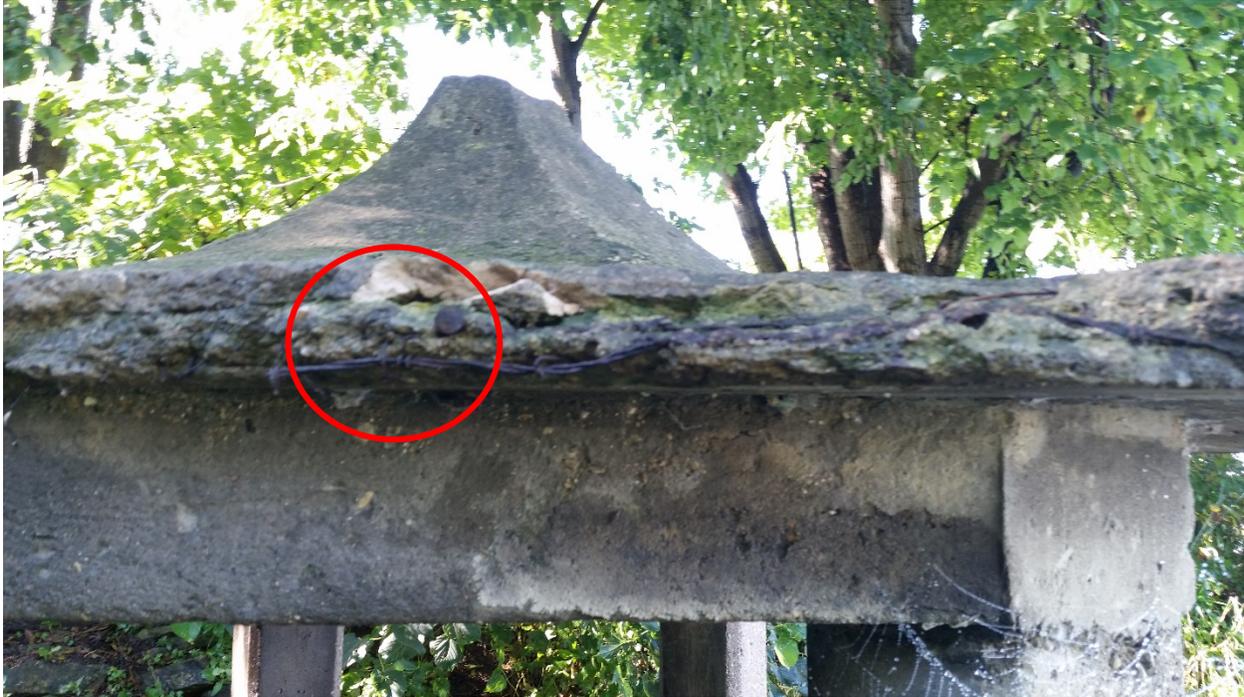
It is the opinion of the structural engineer who made the on-site observations that the pagoda is currently in stable structural condition. With proper design by an engineer and with proper care, technical skill and craftsmanship provided by the contractor, the pagoda foundation and columns are capable of supporting a new replica roof.

**Figure 15: Image of roof edge. September 20, 2016. Note exposed barbed wire segment within concrete and relatively thin section of the roof edge as compared to the beam depth.**

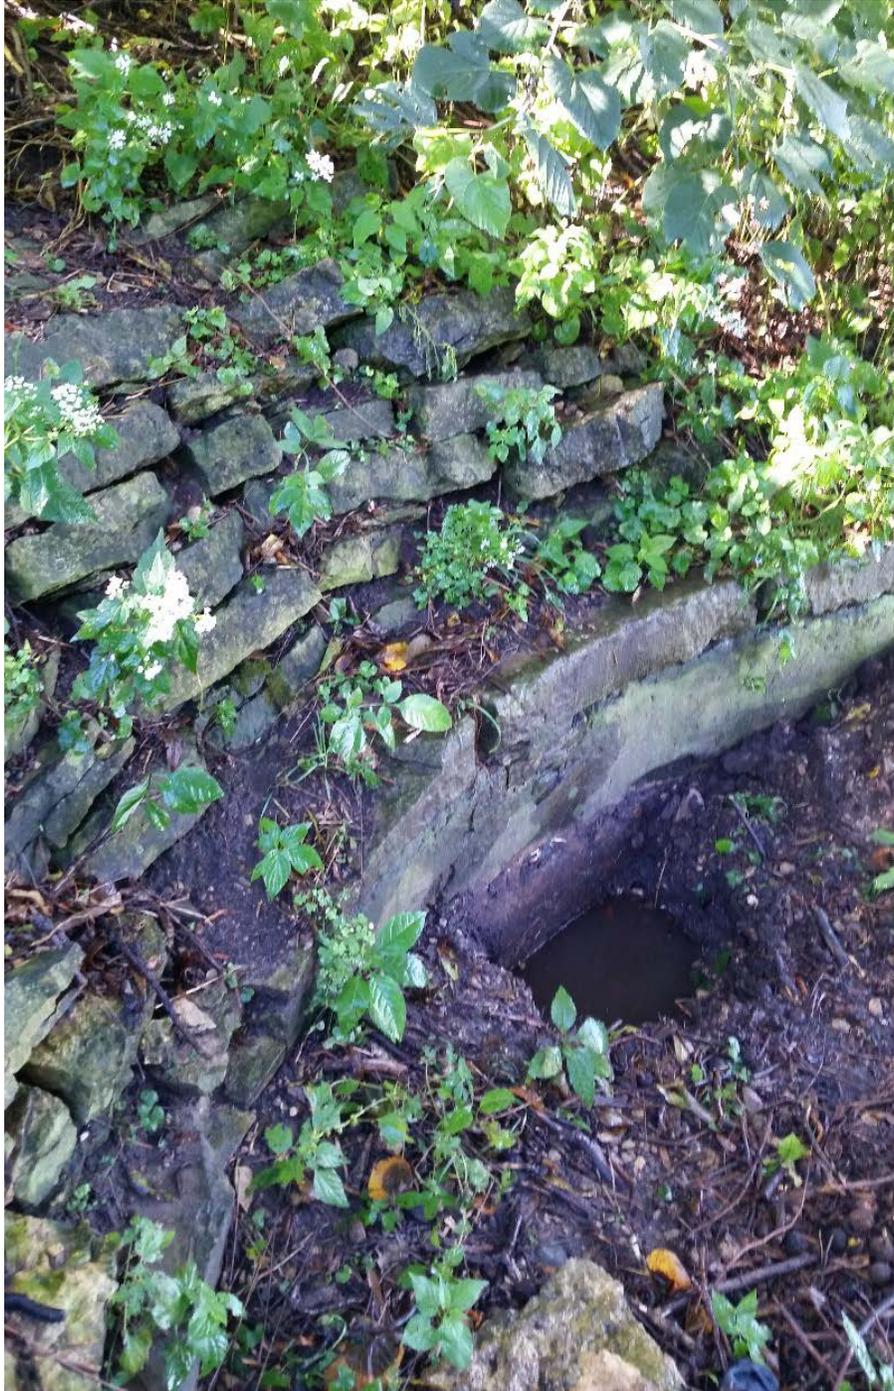
One additional remaining historical element of the site is the stone wall. The stone wall to the south of the pagoda is characterized by two distinct types of stone construction. The lowest, and probably original portion of the wall, is composed stone and mortar. The stone is coursed stone similar to that found in the pagoda foundation.

Above this wall and set back 6 inches is a loose laid dry stack wall composed of squared limestone. Some of these stones may have been salvaged from an original walkway around the base of the pagoda.

The stone wall may have been longer, extending to the east, but may have been impacted by the installation of the Madison Metropolitan Sewerage District sanitary sewer when it was installed parallel to Lake Monona in 1952. This sewer runs north to south approximately nine feet east of the pagoda.

**Figure 16: Image of adjacent stone wall with excavation. September 20, 2016**

The current assumption is that the location of the existing sanitary sewer precludes expanding or relocating the adjacent stone wall. The goal would be to move the wall back far enough from the roof edge to minimize the opportunity for vandals to climb up on the roof. This likely cannot happen, however the stone wall can be improved. Non-original stones of the wall should be removed, the original wall repaired and perhaps expanded to the east. The refurbished stone wall would also provide a more aesthetic backdrop for the refurbished pagoda.

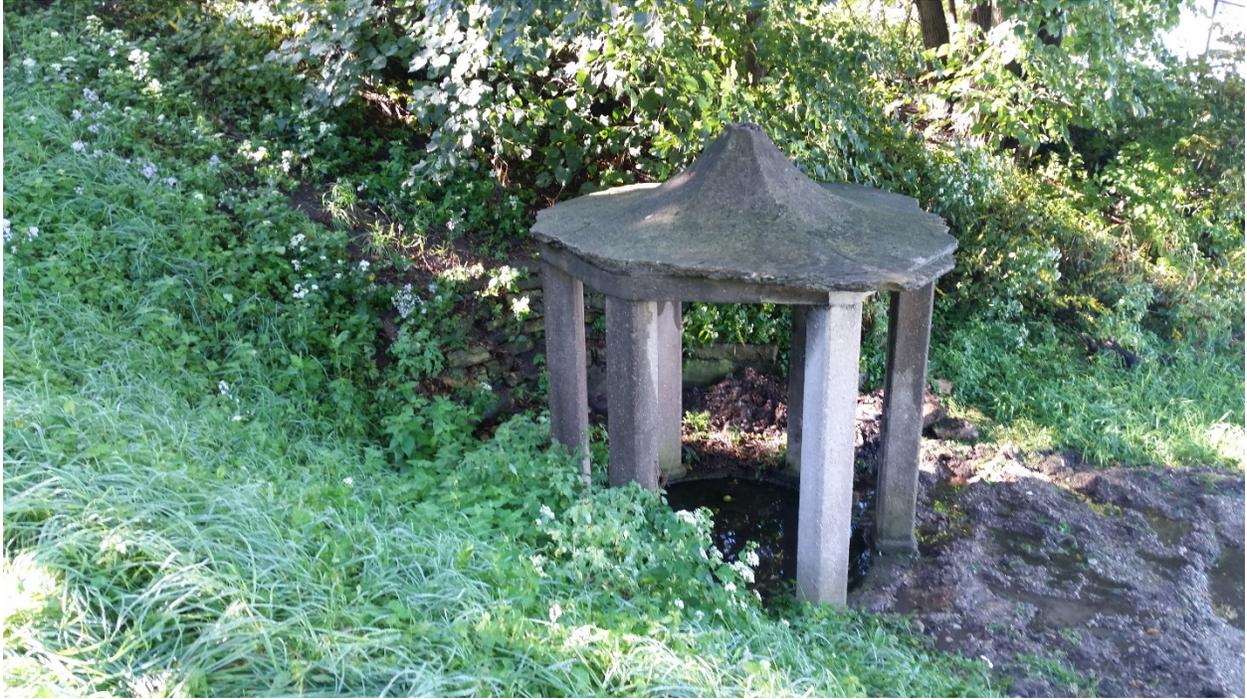
*Springhaven Pagoda, September 20, 2016*

The pagoda is located in Stone Bridge Park along Winnequah Road. This property is within a natural ravine sloping down from the road to Lake Monona. The property, with an outstanding view of central Madison, was part of the late 1880's holdings of Judge E. W. Keyes . The pagoda is constructed over a natural spring.

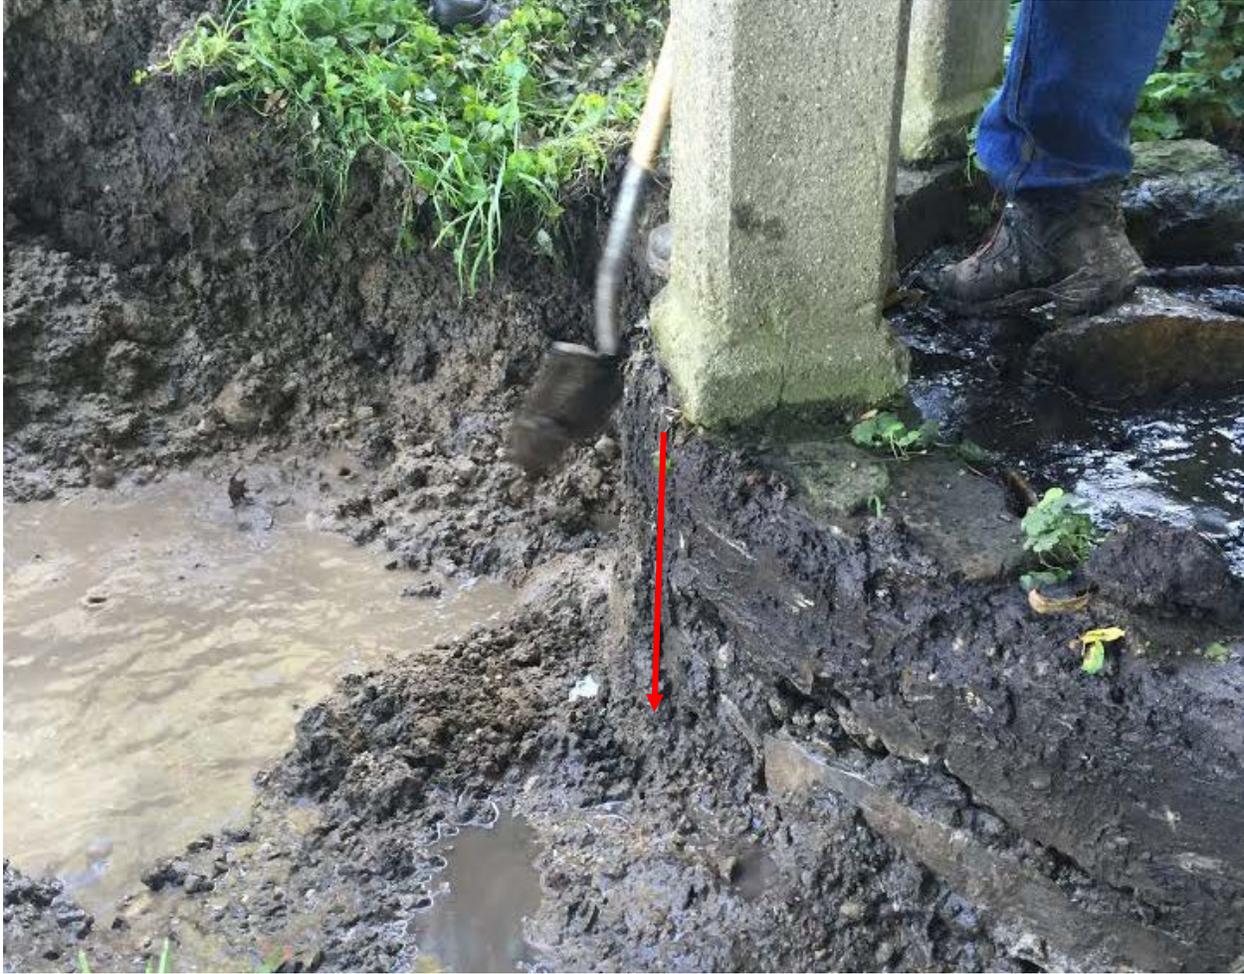
*Image of excavation on September 19, 2016 exposing foundation of Pagoda. Note depth of exposed foundation wall. See also attached sketch on page 7.*

Given the shallow depth of the foundations, not extending below frost level, more movement and displacement of the foundation was expected. It is theorized that the constant temperature of the spring water in the spring basin helps prevent the ground around the pagoda from freezing, thereby minimizing the potential for any heaving and displacement. The foundations are in good condition and performing adequately. The stone walls should be tuck pointed with a Type O mortar.

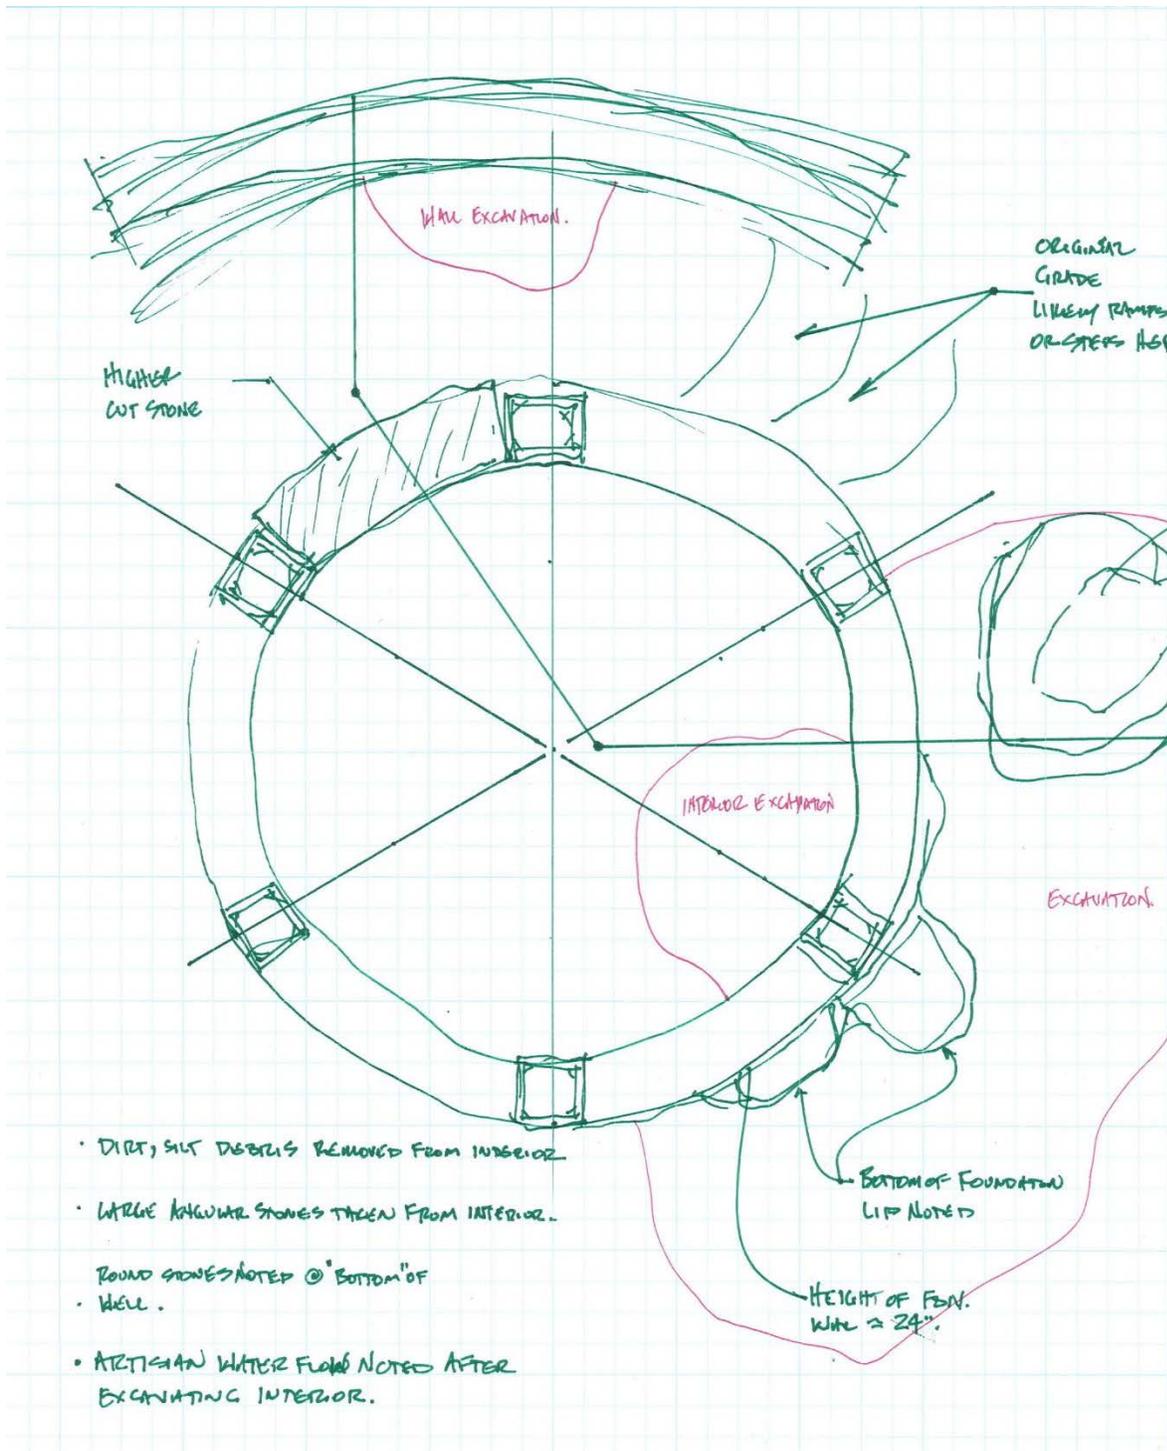
Sketch of base of Pagoda/plan view. September 19, 2016.

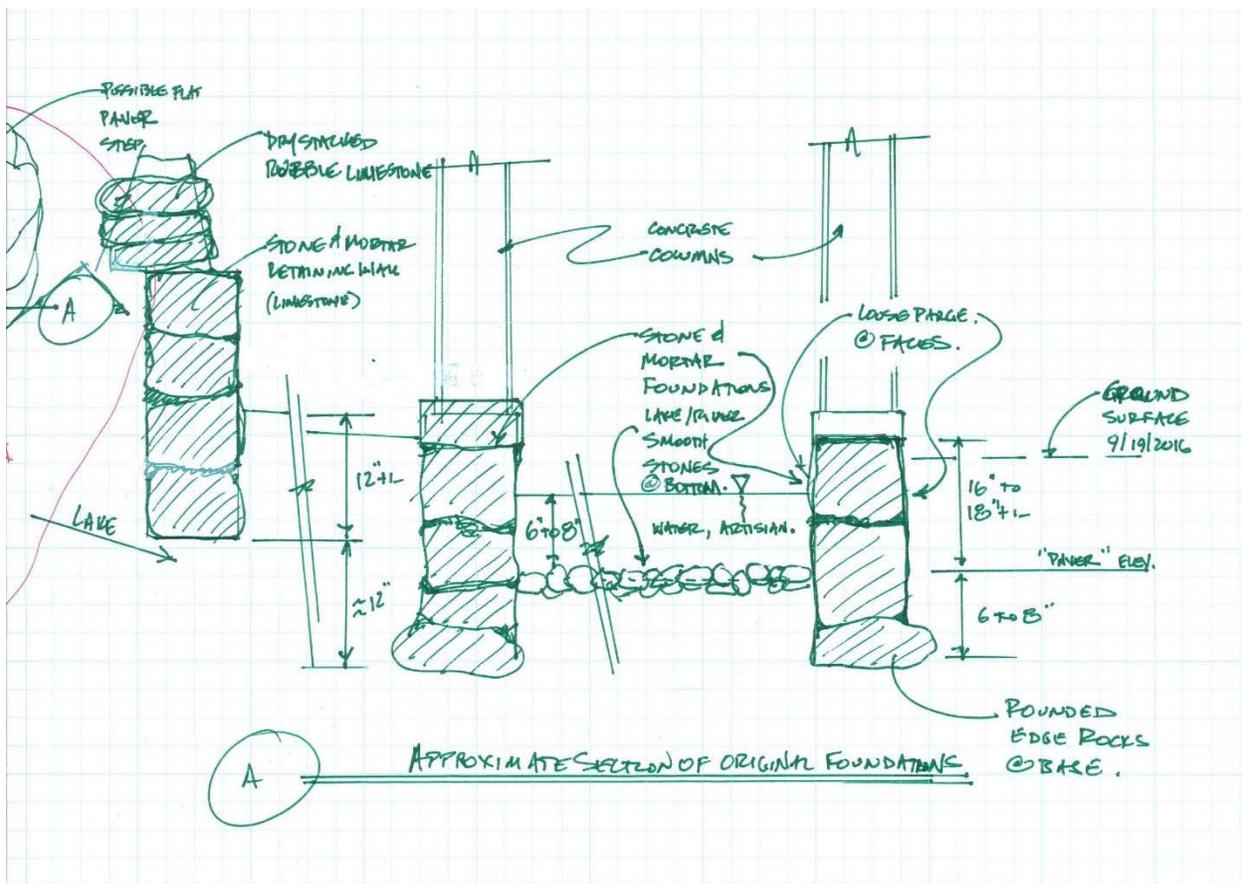
This will facilitate the replacement of the parging. When parging is replaced the smooth stones should then be replaced any missing stone replaced to provide a complete 6 inch layer of smooth stones.

Section sketch of Pagoda Foundation. September 19, 2016

Given the approximate date of construction of the pagoda sometime in the 1890's, the concrete is likely composed of locally sourced materials, including slaked lime, lake sand and coarse aggregate. There is likely no Portland cement content.

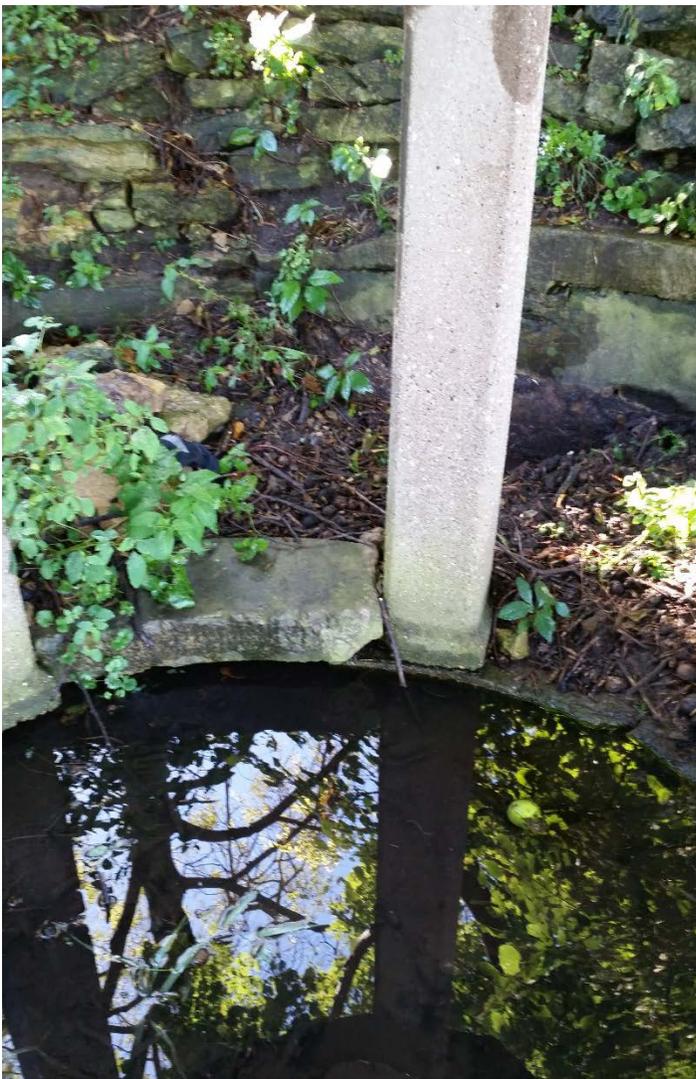
The amount of reinforcing is not known but evidence of the use of lengths of barbed wire and various bolts is observed in the deteriorated edges of the roof structure. It is assumed that the columns have no reinforcing but are pinned to the foundation and beam above in some manner.

*Image of spring basin within Pagoda. Note proximity of stone wall beyond.*

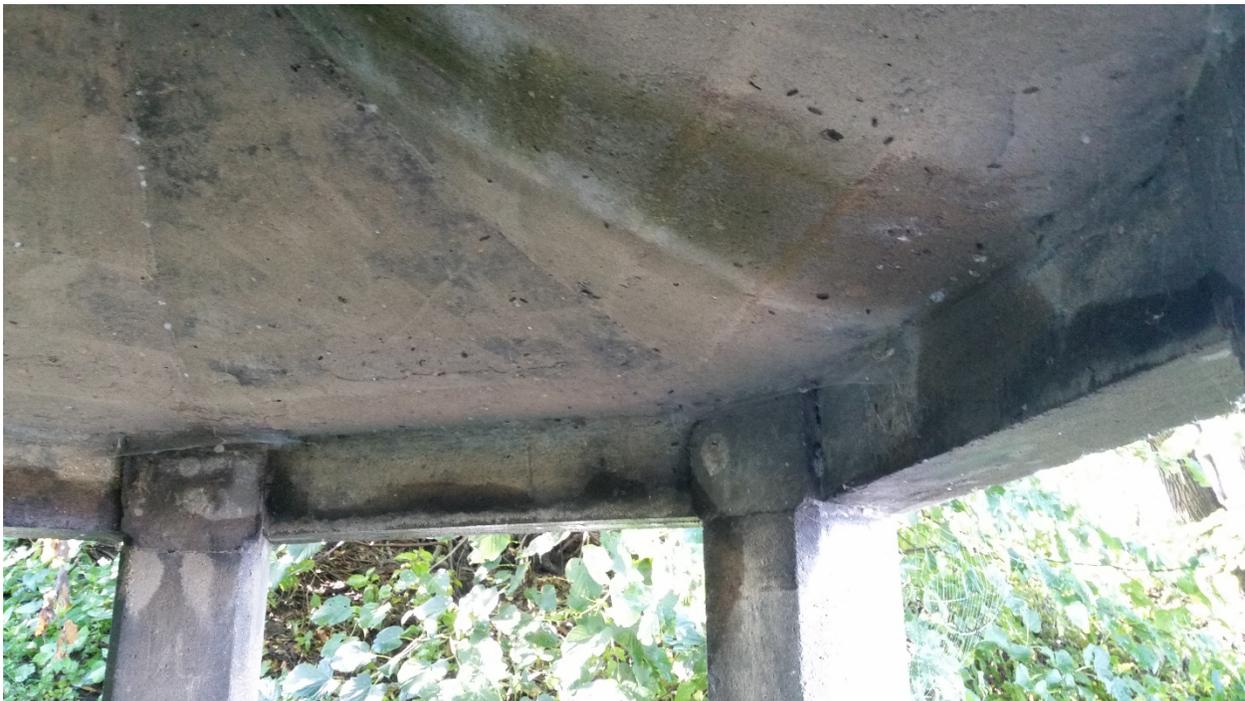
The concrete columns and beams are in good condition. The elements are structurally sound, straight and plumb and performing the intended purpose. The concrete in the 8 inch square columns, with chamfered corners, have few cosmetic imperfections. There is some erosion of the surface on the exposed sides but these columns need no repair. The 6-inch-deep concrete ring beam atop the columns also needs no repair. It appears that the horizontal beam and the upright columns were poured separately. The beams and columns retain a high degree of utility and life expectancy. Although discussed, an application of a Siloxane coating to the concrete surfaces, to resist moisture penetration, is not needed or recommended at this time.

*Image of concrete column, beam and roof juncture, September 201, 2016.*

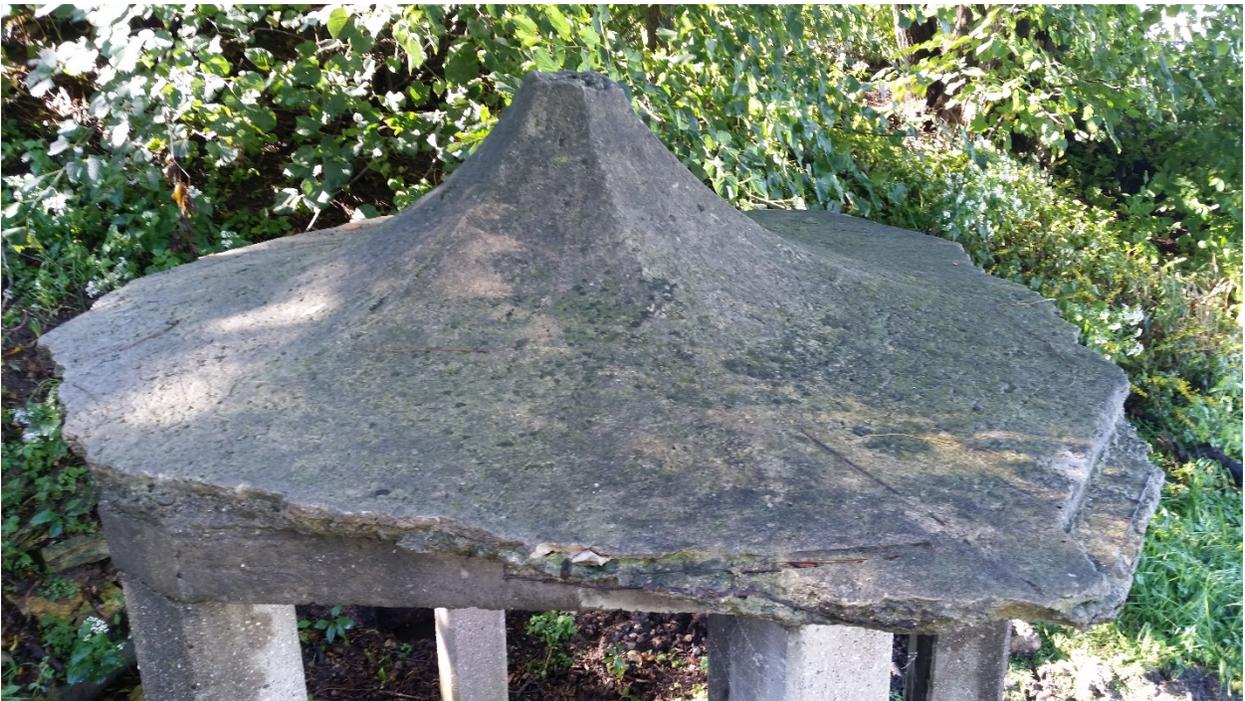
The roof of the pagoda is in overall poor condition. More than 90% of the cantilevered overhang is missing or significantly deteriorated or damaged. This cantilevered portion is less than 3 inches in thickness but over 12 inches wide, therefore very vulnerable to breakage at the edges.

Another source of roof damage is by vandalism. It is apparent that vandals can easily gain access to the roof from the hill to the east and south. Vandals standing and jumping on the roof have likely contributed to the roof edge damage and failure of the concrete cantilever.

*Image of concrete roof, September 20, 2016.*

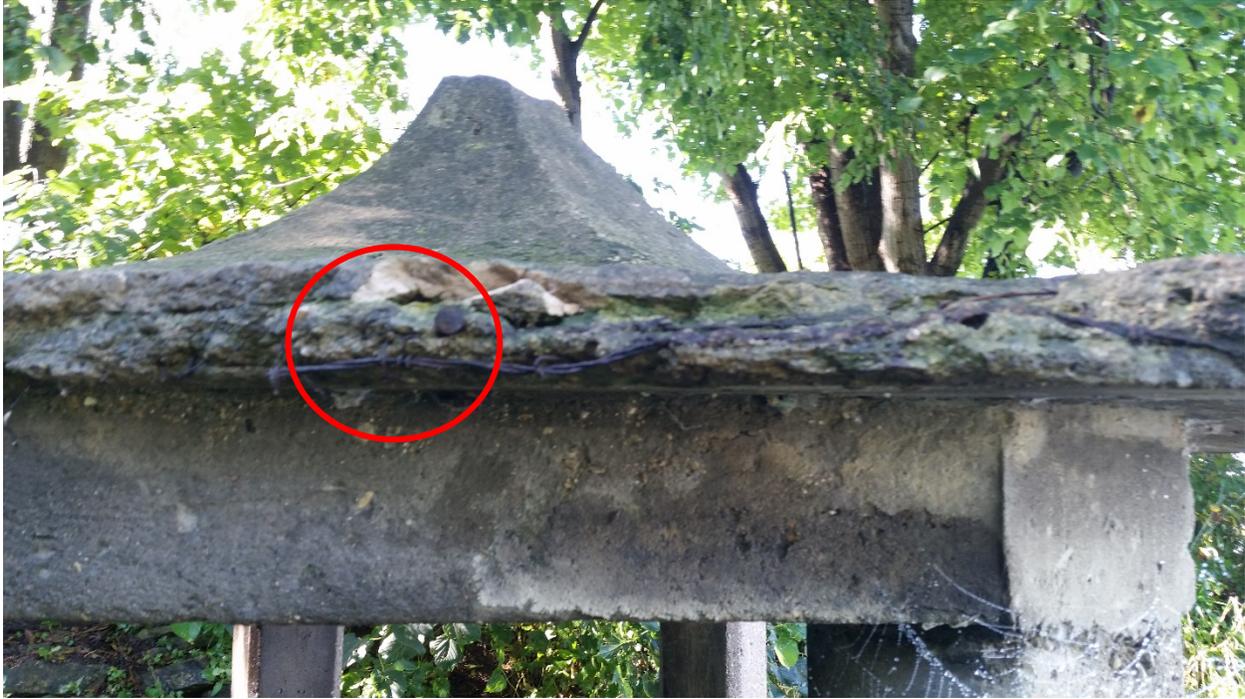
It is the opinion of the structural engineer who made the on-site observations that the Pagoda is currently in stable structural condition. With proper design by an engineer and with proper care, technical skill and craftsmanship provided by the contractor, the Pagoda foundation and columns are capable of supporting a new replica roof.

*Image of roof edge, September 20, 2016.*

*Note exposed barbed wire segment within concrete and relatively thin section of the roof edge as compared to the beam depth.*

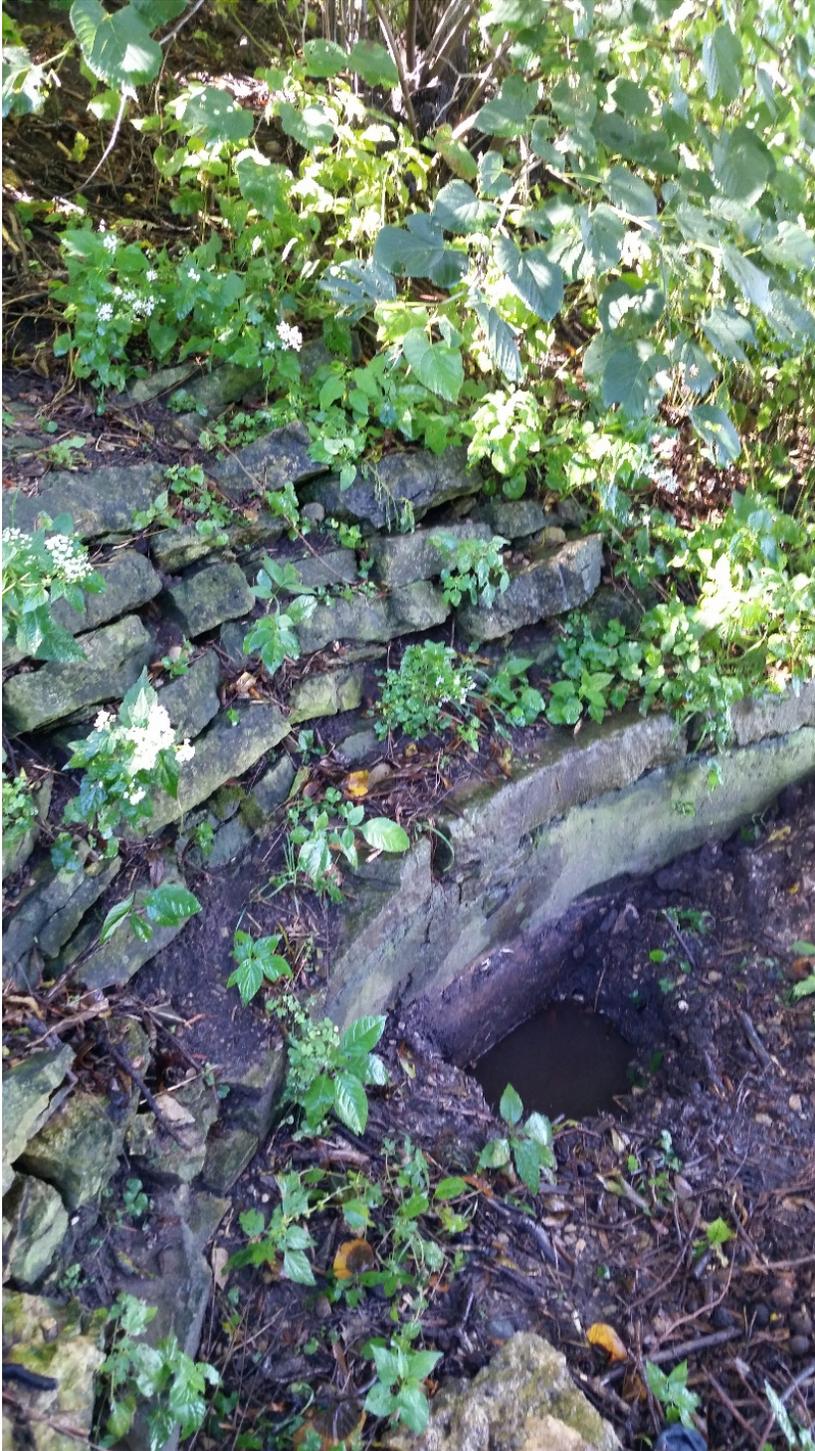
The stone wall may have been longer, extending to the east, but may have been impacted by the installation of the Madison Metropolitan Sewerage District sanitary sewer when it was installed parallel to Lake Monona in 1952. This sewer runs north to south approximately nine feet east of the pagoda.

*Image of adjacent stone wall, September 20, 2016*
